ORNL/RAP/LTR-86/8

DATE: January 1986

SUBJECT: Identification of Low-Level Waste Line Leak Sites  
at Oak Ridge National Laboratory

5. IDENTIFICATION OF LOW-LEVEL WASTE LINE LEAK SITES  
AT OAK RIDGE NATIONAL LABORATORY

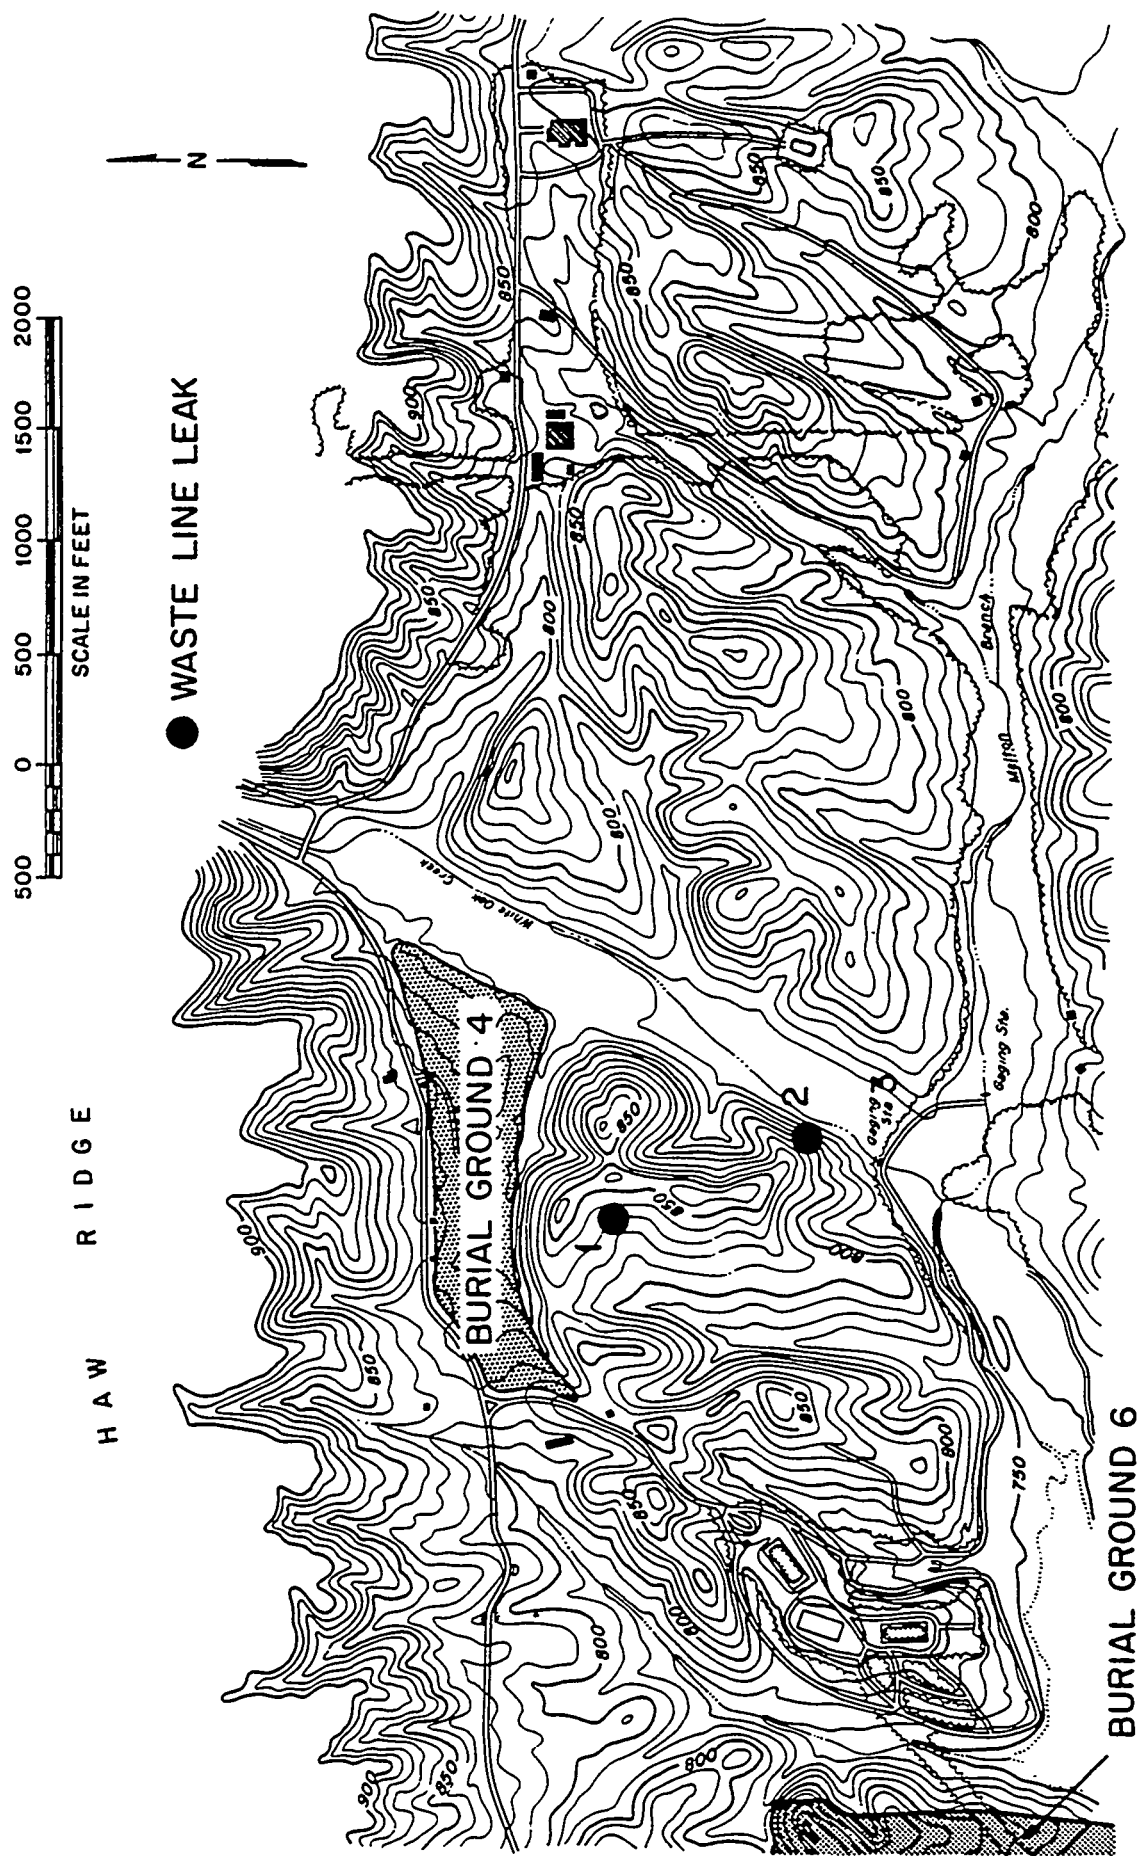
Site 28 Summary - Leak in LLW Transfer Line SE of Trench 6. Site 28 (also referred to as Leak Site 1) is located approximately 150 feet south of LLW Trench 6 (ORNL coordinates N18,363-E27,976). (See Fig. 7) The site slopes to the southwest dropping 15 feet over a distance of 100 feet. The leak was first surveyed in July of 1973 but had occurred at an earlier date and had been repaired. Repair had required limited

Figure 7. Contour Map Showing Location of Waste Line Leaks.

excavation which had been filled by uncontaminated dirt. The contamination was concentrated in a small area near the leak where it had reached the ground surface and spread laterally for several feet. Survey and soil sample analysis indicated radionuclide downslope movement to the southwest. Beta-gamma rates measured at 3 feet above ground surface ranged from 240 mR/hr to 1 R/hr. (See Fig. 8) Soil sample analysis revealed significant mixed fission product contamination with concentrations ranging from 0.01 to approximately 50 Ci/g of beta-gamma activity and gross alpha activities up to 1 nCi/g. The beta-gamma activity was attributed primarily to  $^{137}\text{Cs}$  and  $^{90}\text{Sr}$ . The primary alpha contributor was attributed to  $^{244}\text{Cm}$ , with minor concentrations of  $^{241}\text{Am}$ ,  $^{238}\text{Pu}$ , and  $^{239}\text{Pu}$ . No groundwater monitoring wells were drilled at this site since nearby Trench 6, located nearby, was a known source of groundwater contamination.

Entombment of Sites 28 and 30. The entombment efforts are described by Walls et al.<sup>46</sup> The primary objective was to restrict surface water movement through the leak areas. To accomplish this, two impermeable barriers were constructed over each site: a bentonite clay cap and an asphaltic-concrete pavement cover. See Figs. 10 and 11 for site plans. After removal of the ILW piping in the area and clearance of the sites and their surrounding areas of vegetation (which resulted in the removal of 100 cubic yards of vegetation and contaminated soil), and herbicide application, clean clay fill was placed over the sites. Next, bentonite clay was mixed with the fill. Earth fill was applied over the bentonite clay cap and contoured, a crusted stone base of 6-inches was applied, and 1.5-inches of asphaltic concrete was applied

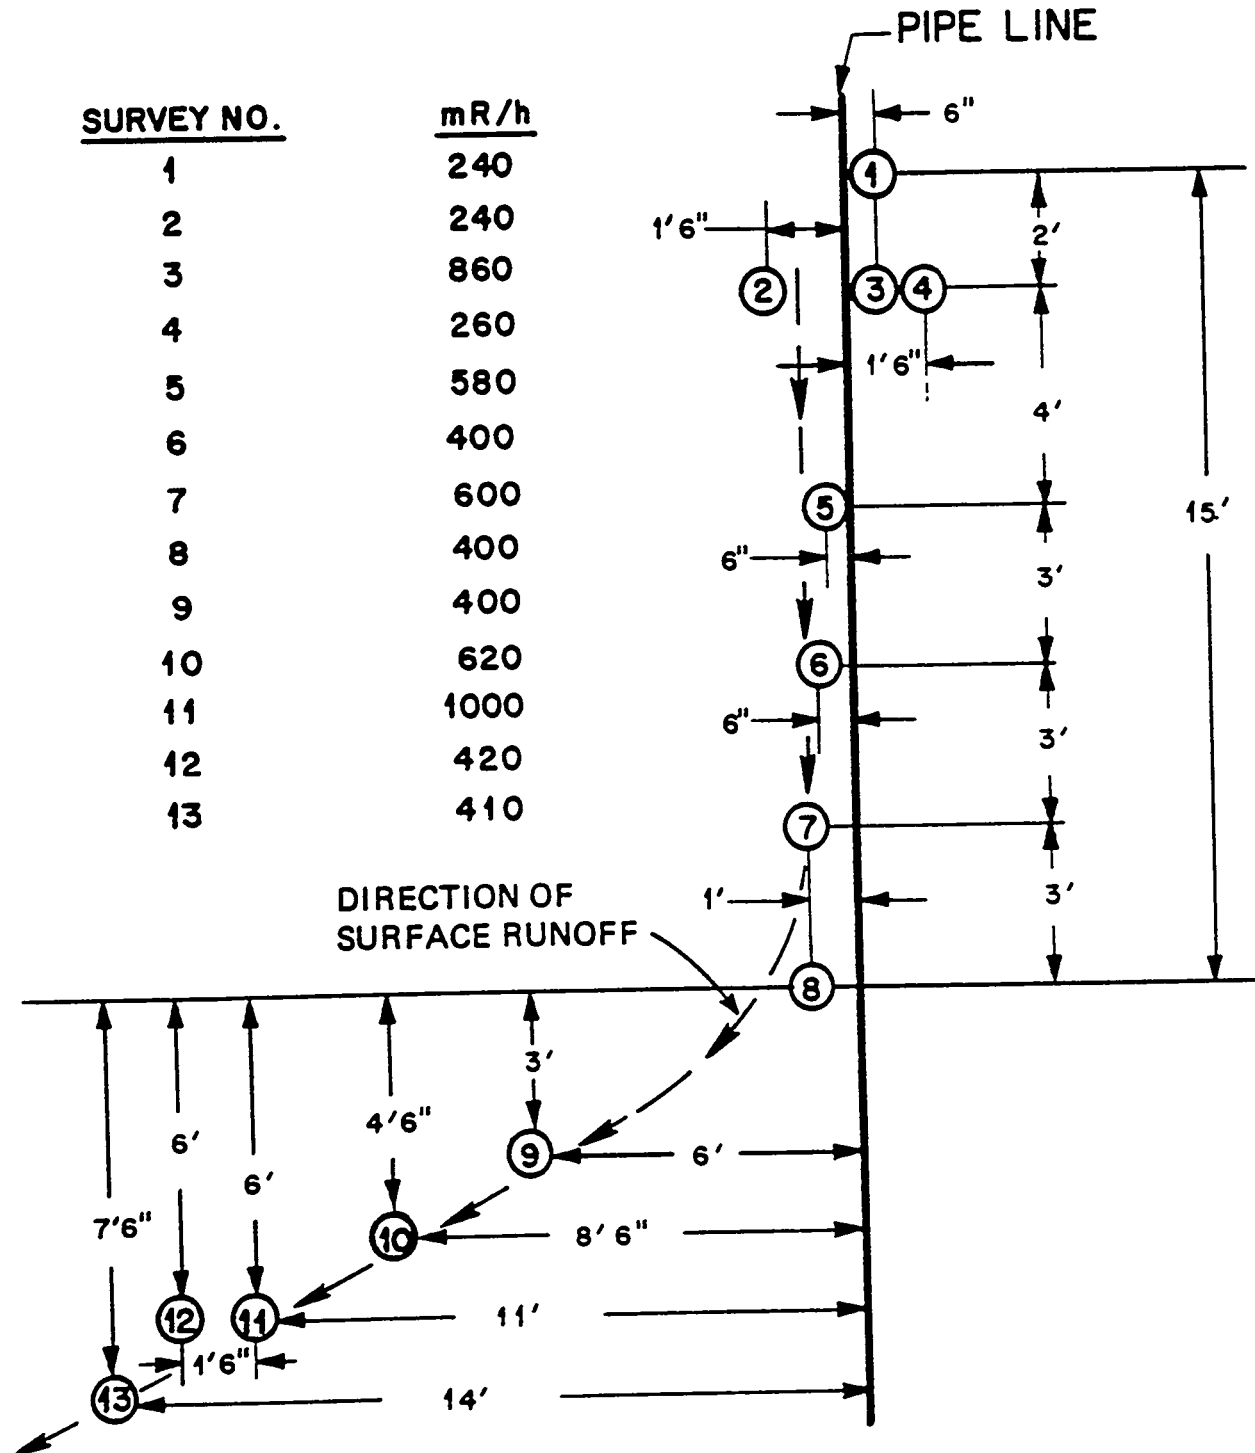
LEAK SITE NO. 1

Figure 8. Beta-gamma survey results at Leak Site No. 1 (Site 28)

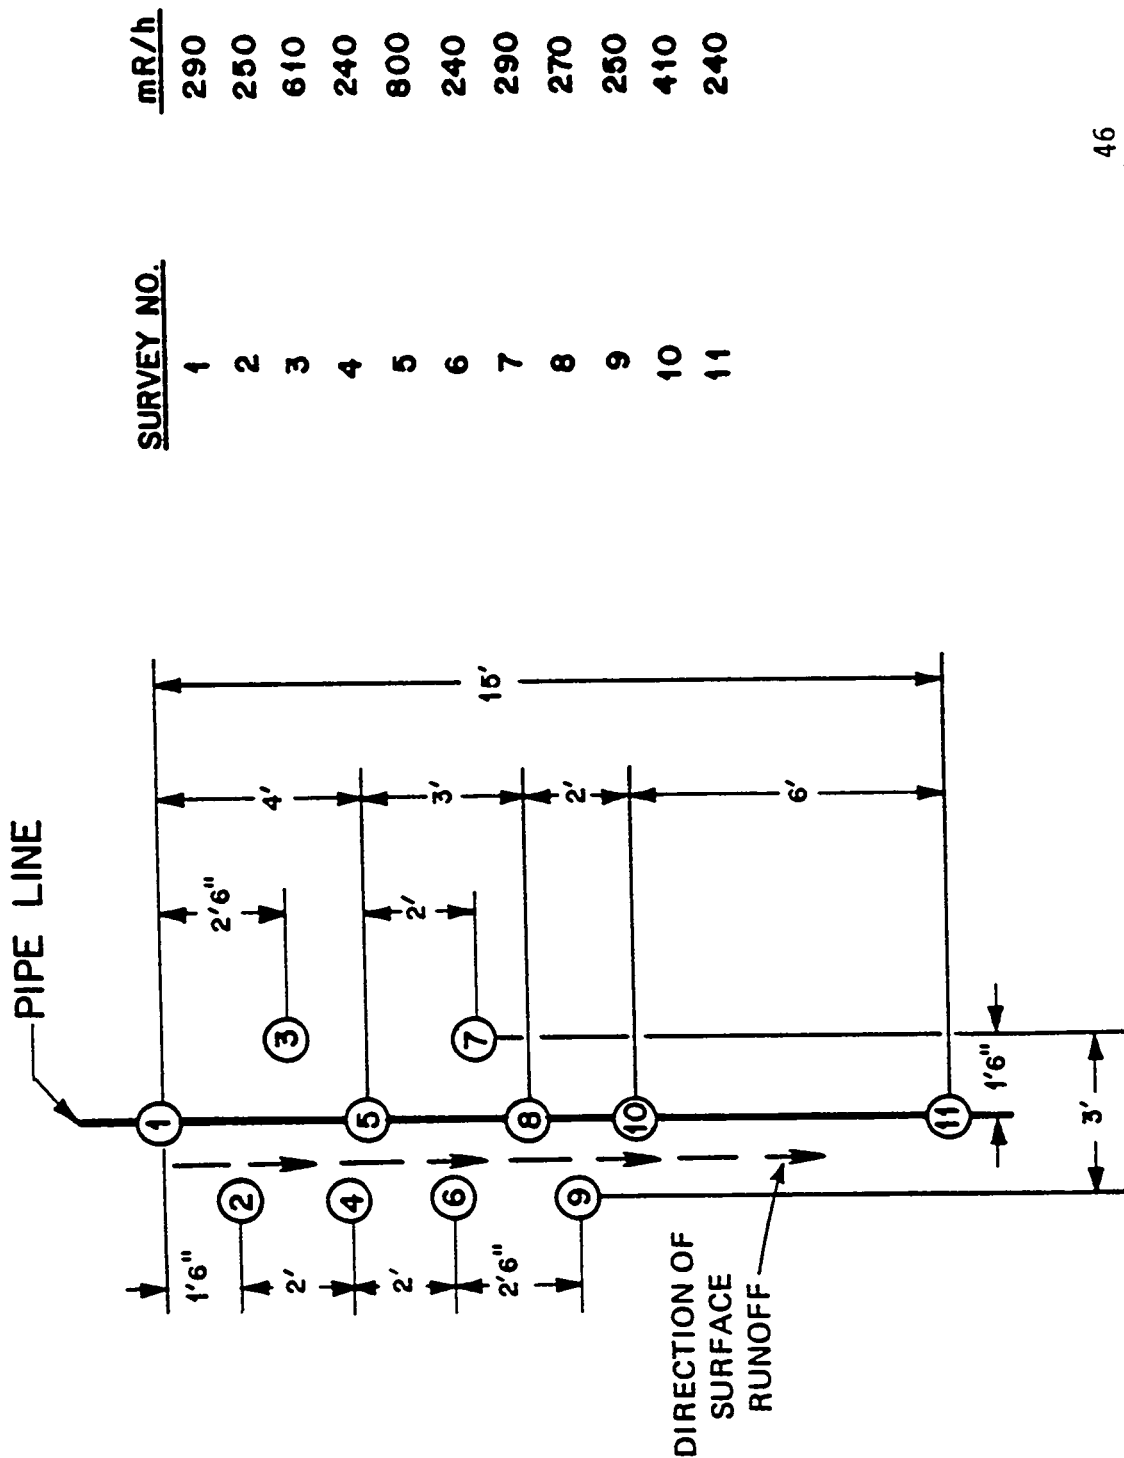
# LEAK SITE NO. 2

Figure 9. Beta-gamma survey results at Leak Site No. 2 (Site 30)<sup>46</sup>

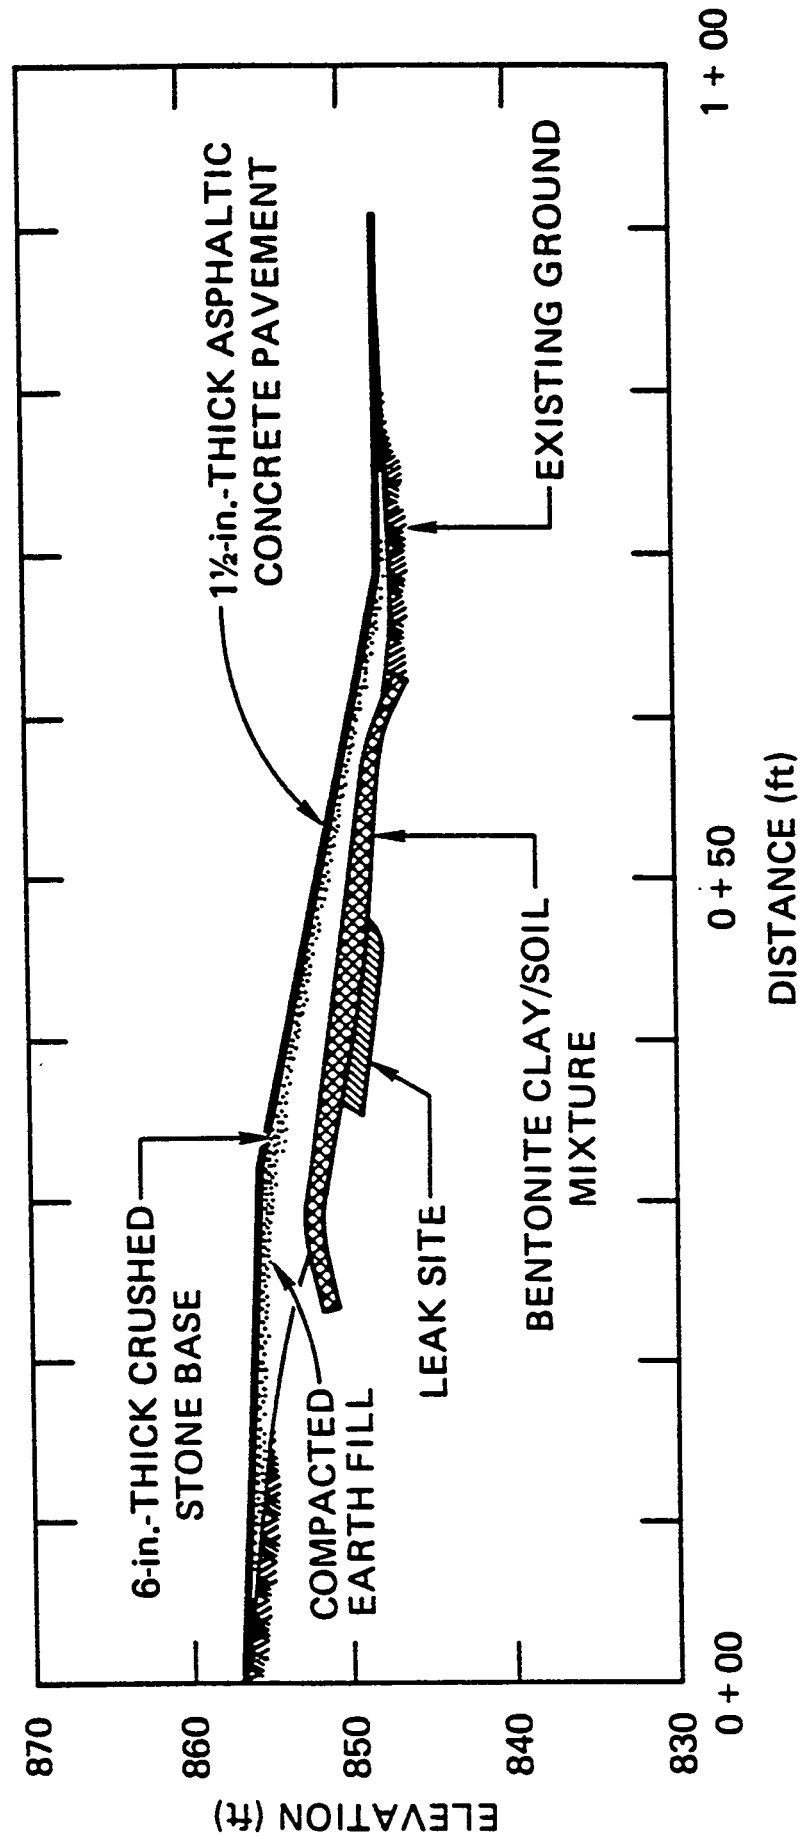
## PROFILE - LEAK SITE NO. 1

Figure 10. Site plan for Leak Site No. 1 (Site 28)<sup>46</sup>

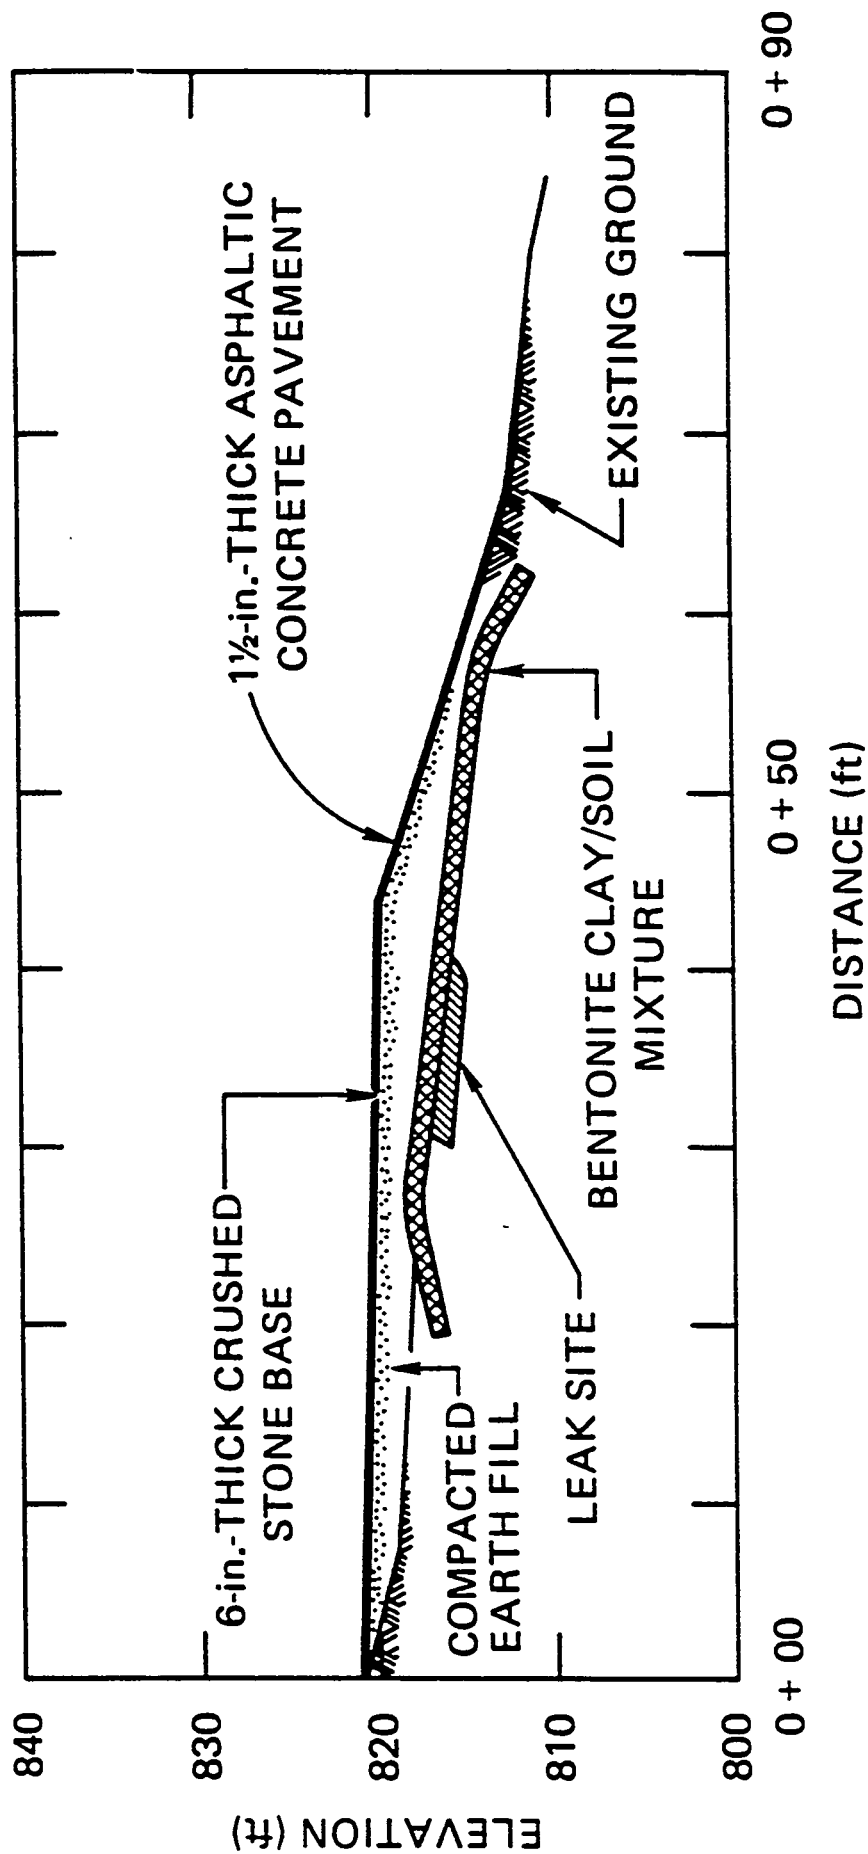
# PROFILE -- LEAK SITE NO. 2

Figure 11. Site plan for Leak Site No. 2 (Site 30)
